VETCAT ENABLED DIAGNOSIS OF INOPERABLE CARCINOMA IN A DOG PRESENTING WITH OTITIS EXTERNA

VETCAT CASE STUDY #6

VETCAT SHOWED POST-EXTRACTION INVASION OF THE NASAL CAVITY AND ENABLED THE DIAGNOSIS OF A PERI-RADICULAR CYST

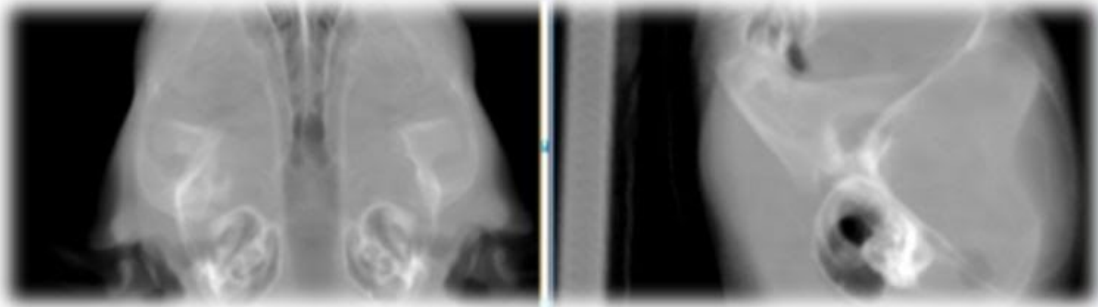
This 3 months old cat presented with a locked jaw but no clear history of trauma. Projection images in 2D are not allowing for a clear diagnosis or possible localization of the disease.

Projection images have limited diagnostic value when attempting to identify TMJ disease

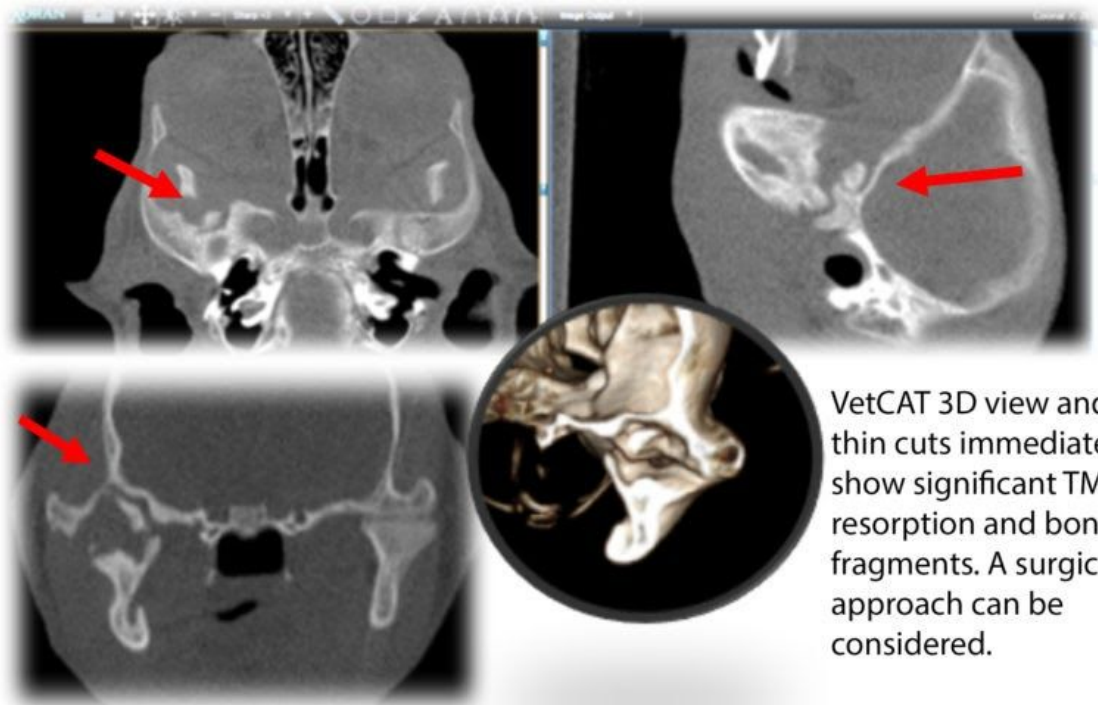
VetCAT 3D view and thin cuts immediately show significant TMJ resorption and bone fragments. A surgical approach can be considered.

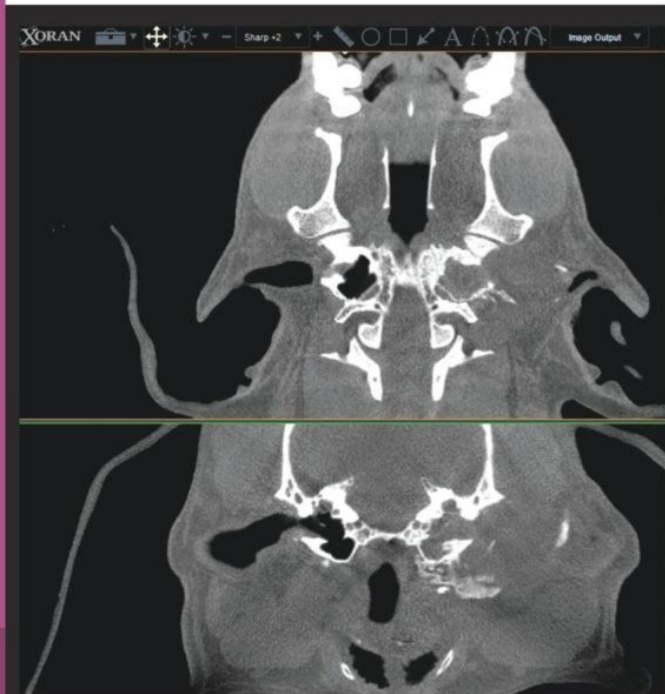
Figure 1

A VetCAT CT scan was taken to evaluate the extent of the pathology (Figure 1).

The lesion was found to be obliterating the canal, middle and inner ear.

Soft tissue inflammation was also visible on the VetCAT CT.

Bony expansion and diffuse borders were indicative of adenocarcinoma or squamous cell carcinoma.

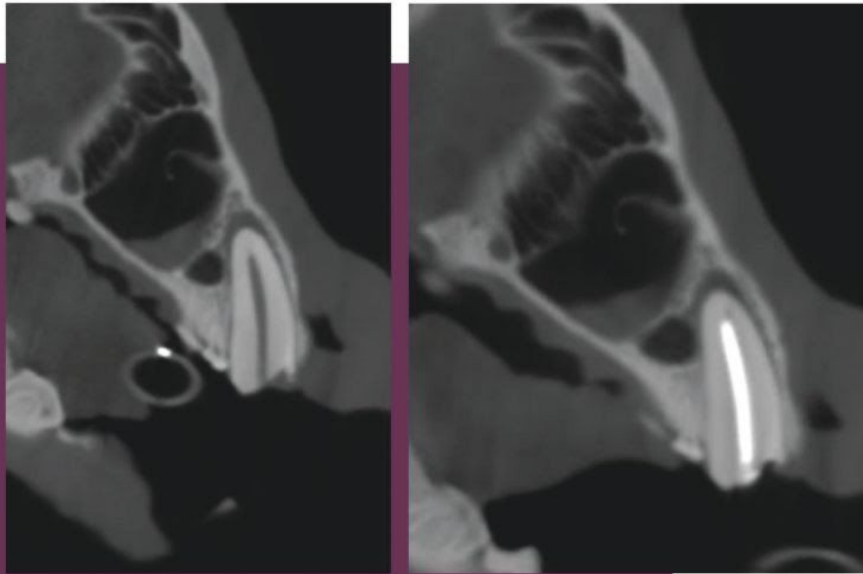
A crown fracture on this wolverine resulted in exposure of the pulp, necrosis and periapical lesion.

Endodontic therapy was performed and immediately evaluated using VetCAT.

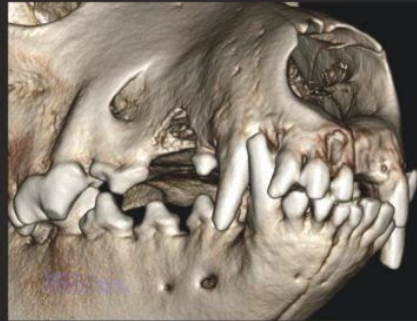
Figure 1

A VetCAT CT scan was taken to evaluate healing in the area of 106 and an undetermined lesion at the location of 101/102 (Figure 1).

The extraction socket showed communication with the nasal cavity, and monitoring was advised.

The anterior lesion was immediately diagnosed as a peri-radicular cyst due to its well defined walls.

Adjacent roots and the palatal wall were intact, whereas the buccal bony wall was missing.

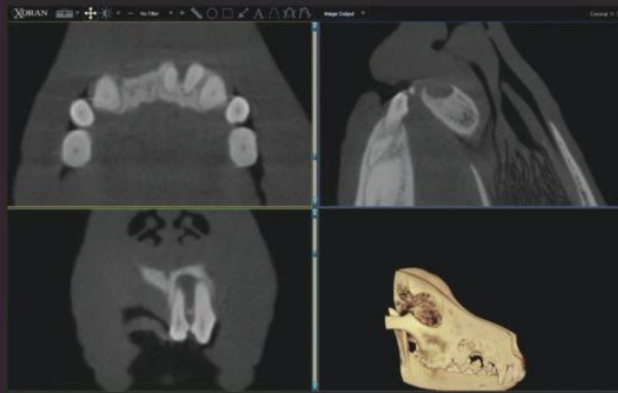
Figure 2

Other views of the cyst clearly show its extent (Figure 2).

The buccal approach apico-coronal location are obvious with VetCAT 3D imaging.

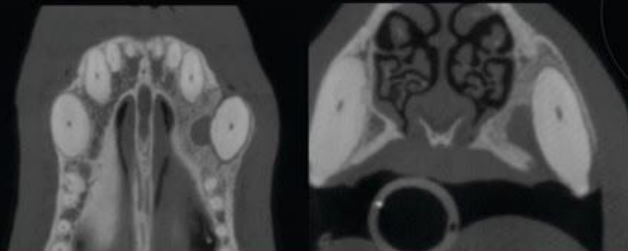
2D x-rays had limited value when attempting to predict the extent of the defect.

VetCAT high resolution coronal and axial views show the exact extent of the disease.

Immediately following VetCAT scanning, a predictable surgical approach is successfully completed.
